MISSOURI - KANSAS CITY RIVER BASIN

BOCO MO DAM
BOONE COUNTY, MISSOURI
MO. 10893

PHASE I INSPECTION REPORT NATIONAL DAM SAFETY PROGRAM

SEPTEMBER, 1980

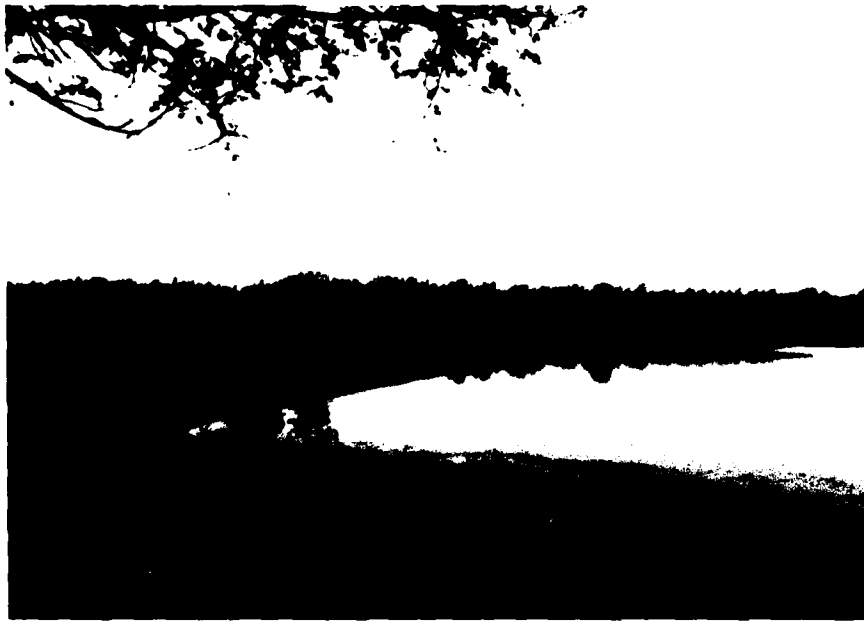
The upstream slope of the dam has no riprap protection. Consequently, some erosion has occurred on the upstream side of the berm due to wave action. The portion of the slope above the water surface and the berm itself have a tall grass cover. The grass cover is not dense enough to adequately protect the slope from surface runoff. Some minor erosion due to surface runoff was observed; however, no large erosion gullies were noted. Considerable damage to the surface of the embankment slopes has been caused by grazing livestock. Small 6-inch diameter depressions and shallow surface sloughs due to the livestock activity were observed. Longitudinal and transverse cracks were observed over most of the slope. The cracks were noncontinuous and some were measured up to 8 inches deep, 1/2-inch wide, and 6-feet long. No bulges or depressions were observed on the slope.

2. The wave erosion on the upstream berm and the areas of surface runoff erosion downstream of the toe do not appear to affect the structural stability of the dam in their present condition. However, continual erosion due to wave action can only be detrimental to the stability of the dam. The erosion downstream of the toe of the dam, if allowed to continue, could encroach upon the toe and endanger the safety of the dam.

- Photo 1 - Overview of the upstream slope showing the location of the service spillway drop inlet and the wave erosion along the berm.
- Photo 2 - View of the top of dam looking toward the right abutment.
